**SITE INSPECTION EXPANDED TRIP REPORT  
FOR  
JARD COMPANY, INC.  
SITE REASSESSMENT  
BENNINGTON, VERMONT**

**EPA REGION I SUPERFUND PROGRAM  
TRIP REPORT/CHECKLIST**

**Site Name:** Jard Company, Inc.  
**Address:** 259 Bowen Road  
**Town:** Bennington  
**State:** Vermont (VT)

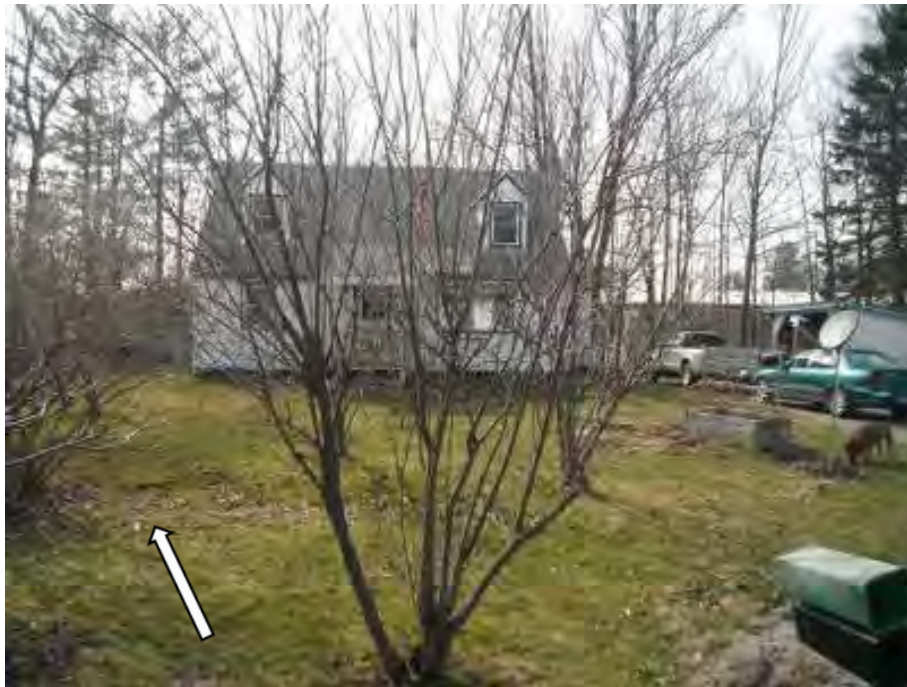
**FRAME NUMBER:** DSCF0539.JPG  
**PHOTOGRAPHY BY:** J. Saylor

**SCENE:** View of Property P021 from Bowen Road. To the right of the residence, there is a driveway with parked vehicles and a woodshed. Surface soil sample location P021-SS-03 is in the front yard of Property P021. Photograph taken facing west.

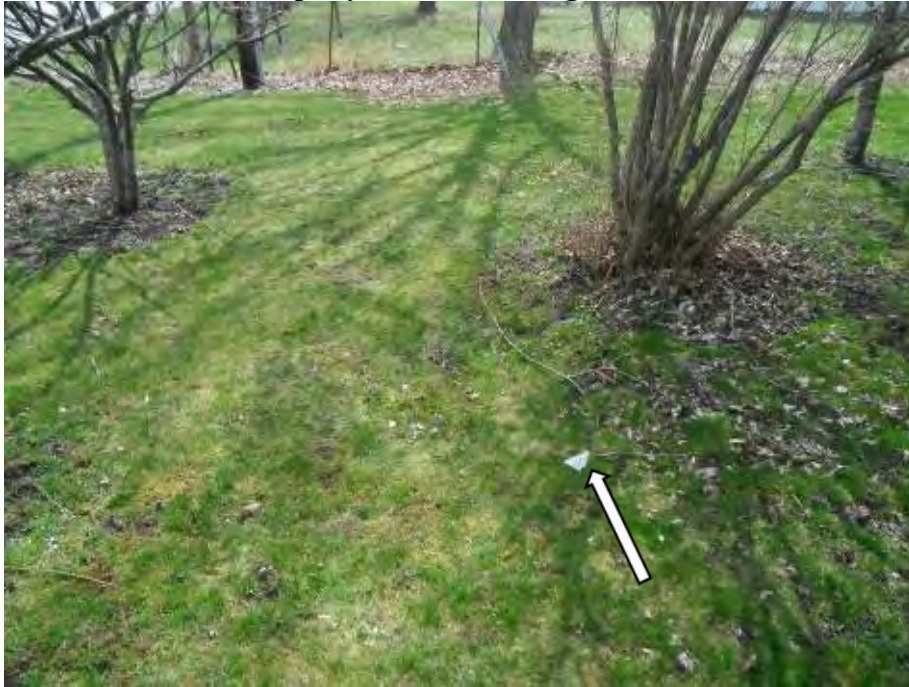
**FRAME NUMBER:** DSCF0456.JPG  
**PHOTOGRAPHY BY:** K. Robinson

**SCENE:** View of P021-SS-03 located in the front yard of Property P021. Bowen Road is visible in the upper left corner, and the neighboring property is visible in the background beyond the metal fence. Photograph taken facing south.

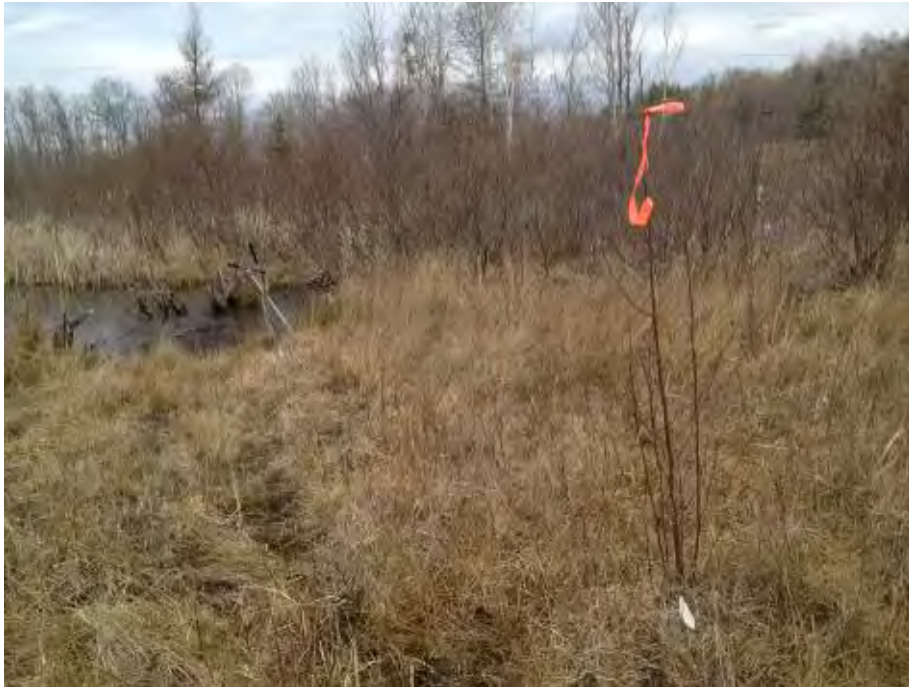
**FRAME NUMBER:** DSCF0547.JPG  
**PHOTOGRAPHY BY:** J. Saylor

**SCENE:** View of sediment sampling location SD-52 in wetlands east of Bowen Road, indicated by the orange flagging and the white pin-flag. Open water body is visible to the left. Photograph taken facing west.

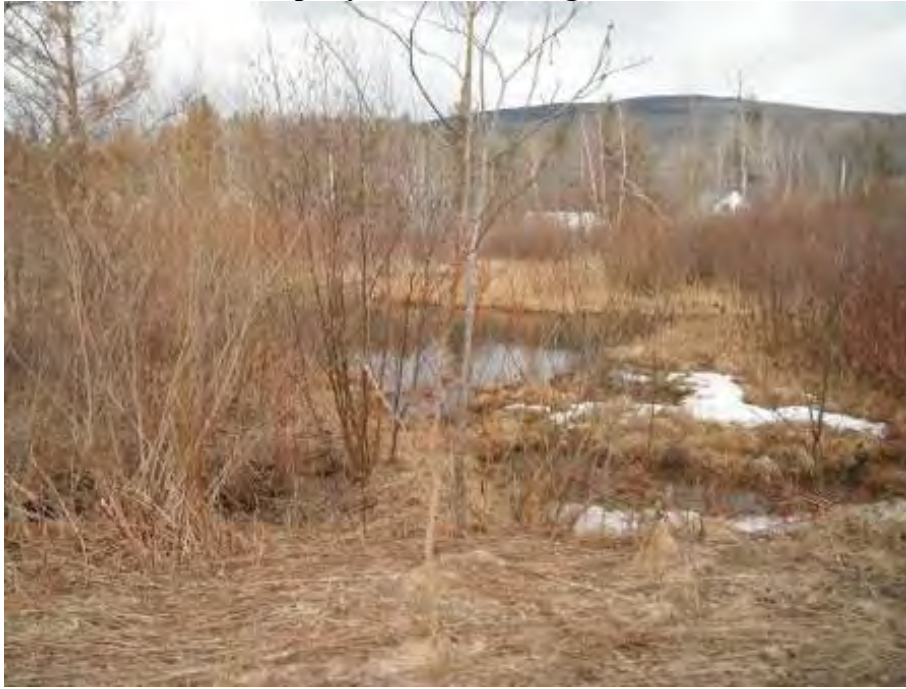
**FRAME NUMBER:** CS\_Photos 033.JPG  
**PHOTOGRAPHY BY:** C. Scesny

**SCENE:** View of the background wetland area east of Bowen Road. Open surface water body is visible (center). Photograph taken facing west.

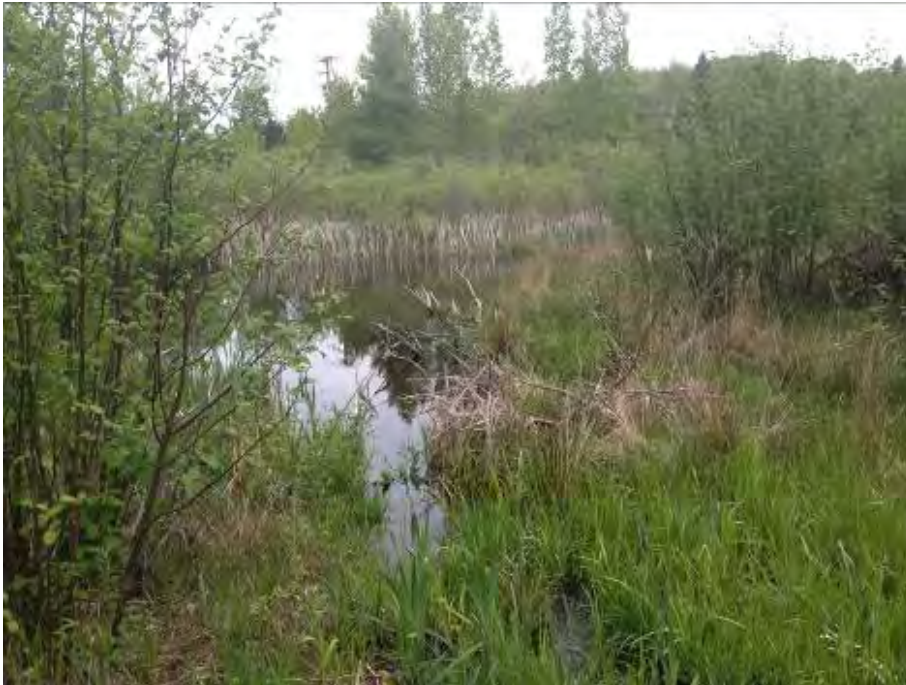
**FRAME NUMBER:** DSCF0382.JPG  
**PHOTOGRAPHY BY:** G. Hornok

**SCENE:** View of background wetlands near sediment sampling location SD-55. Open surface water body is fed by an intermittent stream in the foreground. Photograph taken facing west.

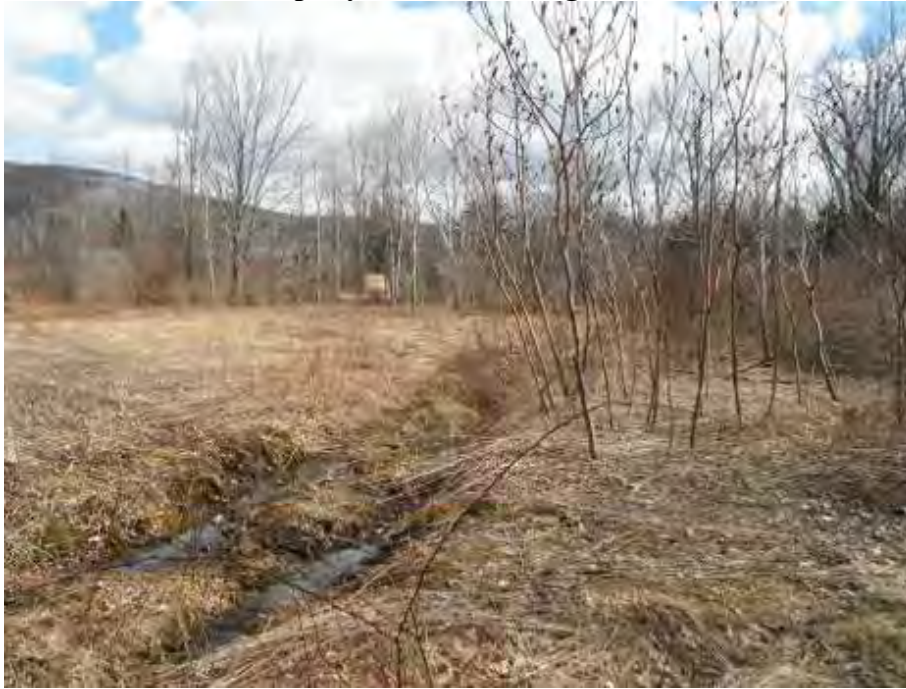
**FRAME NUMBER:** KR018.JPG  
**PHOTOGRAPHY BY:** K. Robinson

**SCENE:** View of sediment sampling location, indicated by orange flagging in trees, in wetlands west of Park Street. Photograph taken facing southeast.

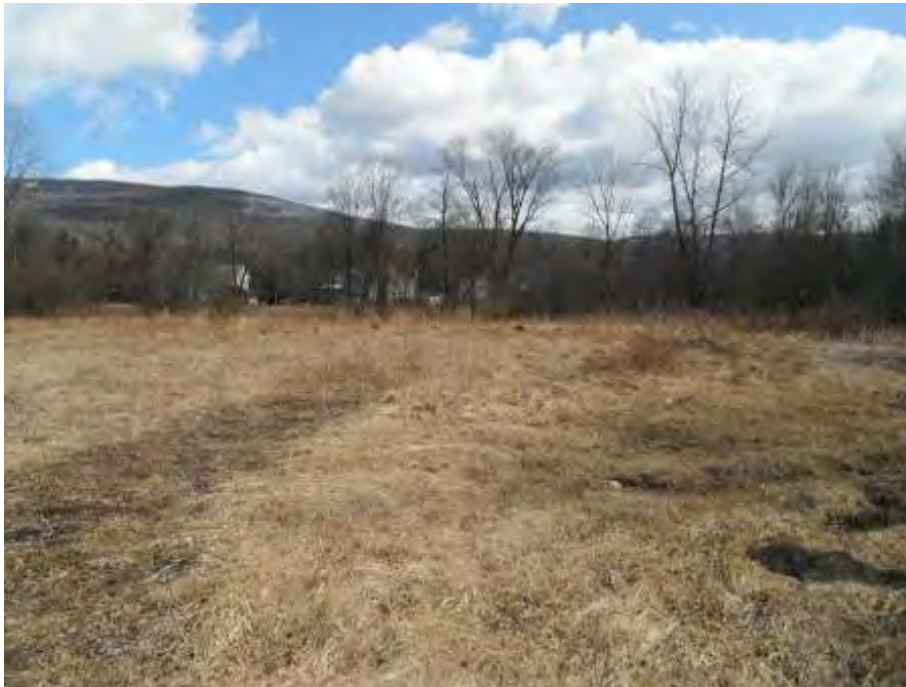
**FRAME NUMBER:** DSCF0372.JPG  
**PHOTOGRAPHY BY:** G. Hornok

**SCENE:** View of grassy field west of sediment sampling locations in wetlands behind Park Street residences. Several residences are visible in the background. The ponded areas are located in the wooded area to the right. Photograph taken facing west.

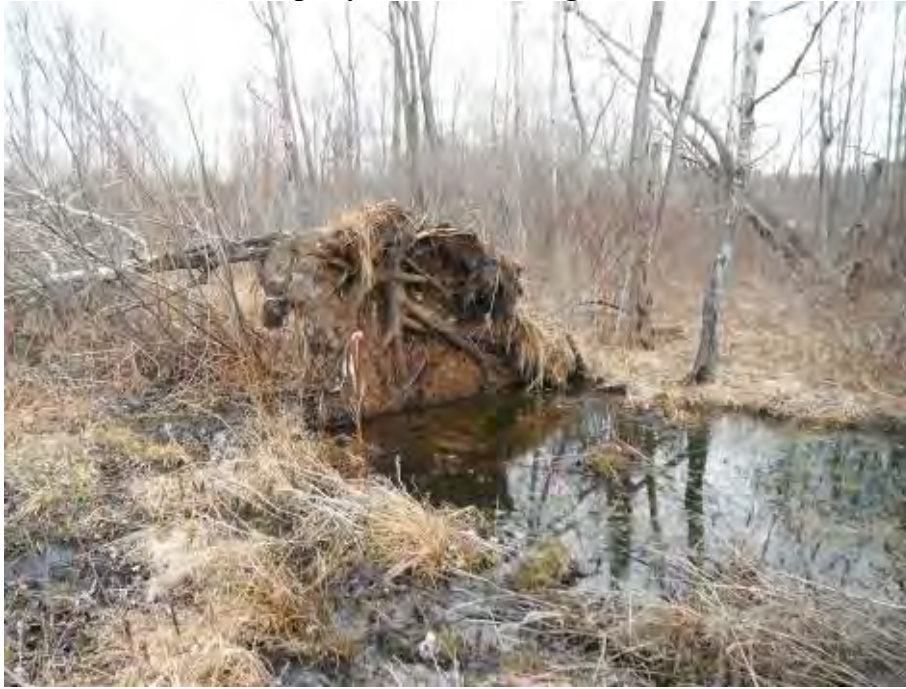
**SCENE:** View of potentially impacted wetlands west of Park Street. Note the standing surface water at the base of the uprooted tree. Photograph taken facing south.

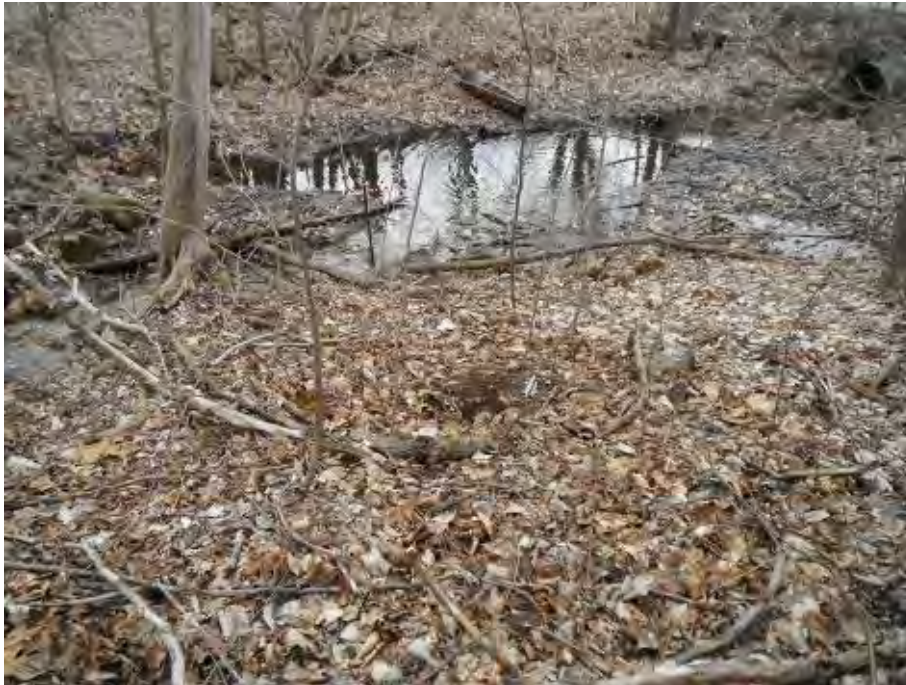
**FRAME NUMBER:** DSCF0440.JPG  
**PHOTOGRAPHY BY:** G. Hornok

**SCENE:** View of stream east of Park Street near the athletic fields. The culvert in the upper right corner drains from the small pond located on Property P011. Photograph taken facing southeast

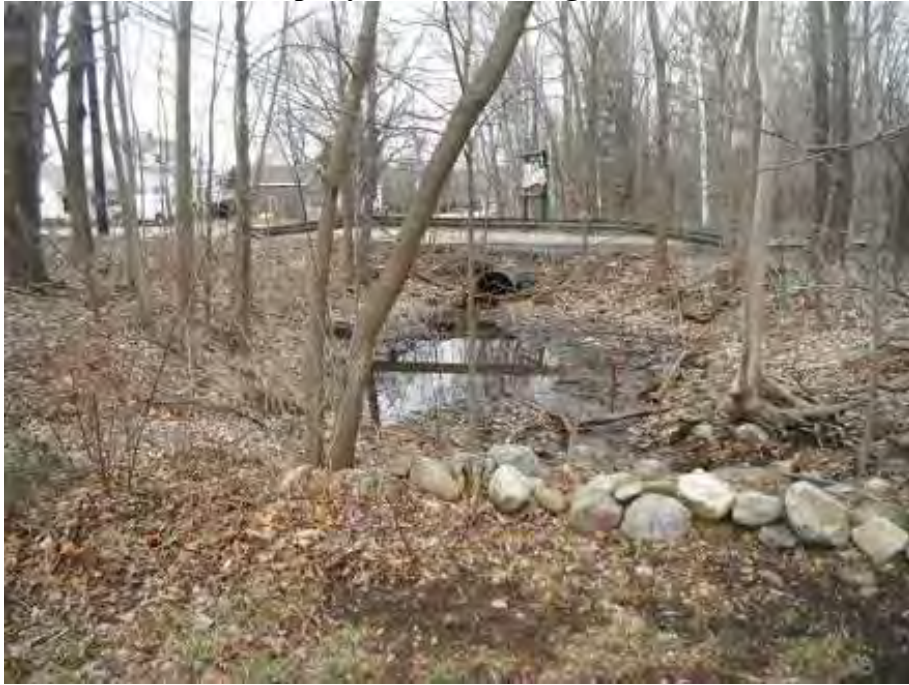
**FRAME NUMBER:** DSCF0464.JPG  
**PHOTOGRAPHY BY:** G. Hornok

**SCENE:** View of small pond on northwest corner of Property P011. Several sediment samples collected from the edge of the pond, and surface soil sample P011-SS-02 was collected to the right of the pond. Property P009 and Property P008 are visible in the background on the west side of Park Street. The entrance to the athletic fields is visible above the culvert. Photograph taken facing north.

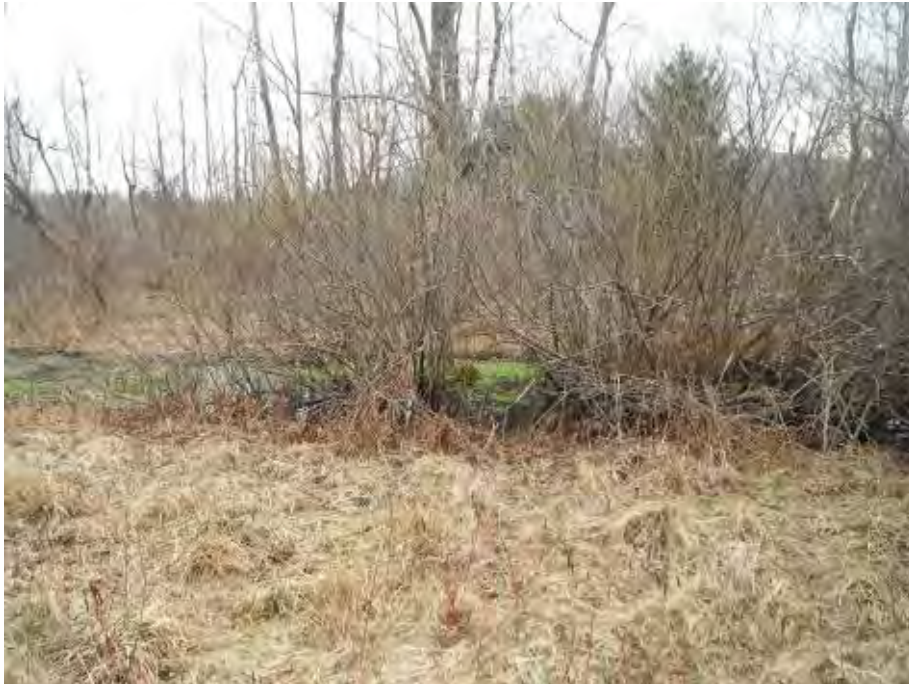
**FRAME NUMBER:** DSCF0465.JPG  
**PHOTOGRAPHY BY:** G. Hornok

**SCENE:** View of sediment sampling location at the edge of a manmade pond in the wetlands west of Park Street. Photograph taken facing south.

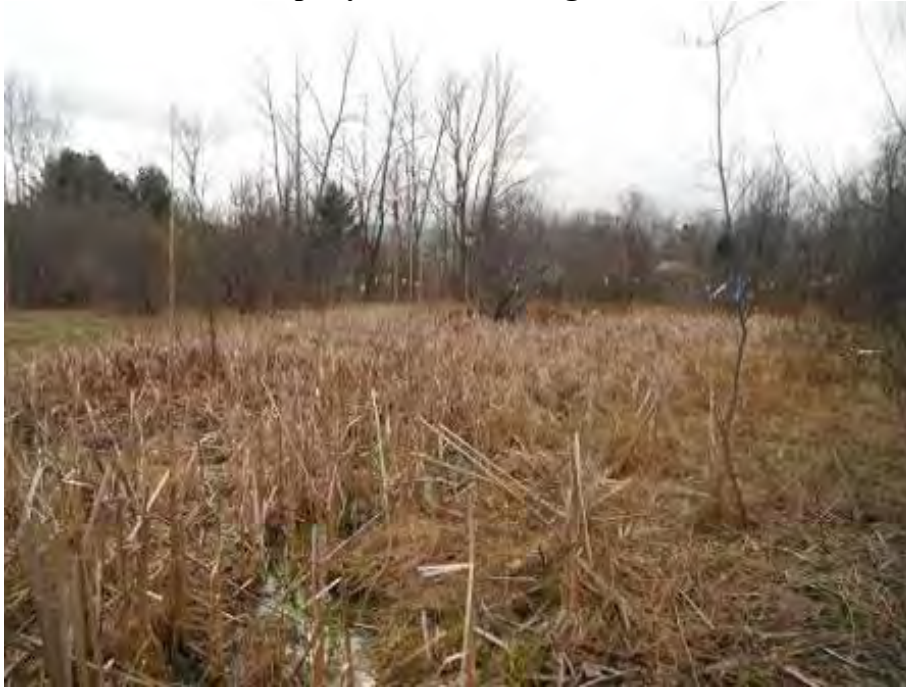
**FRAME NUMBER:** DSCF0563.JPG  
**PHOTOGRAPHY BY:** G. Hornok

**SCENE:** View of potentially impacted wetlands west of Park Street. Blue wetland delineation flagging is visible in a tree to the right. Residences are visible in the background. Photograph taken facing southeast.

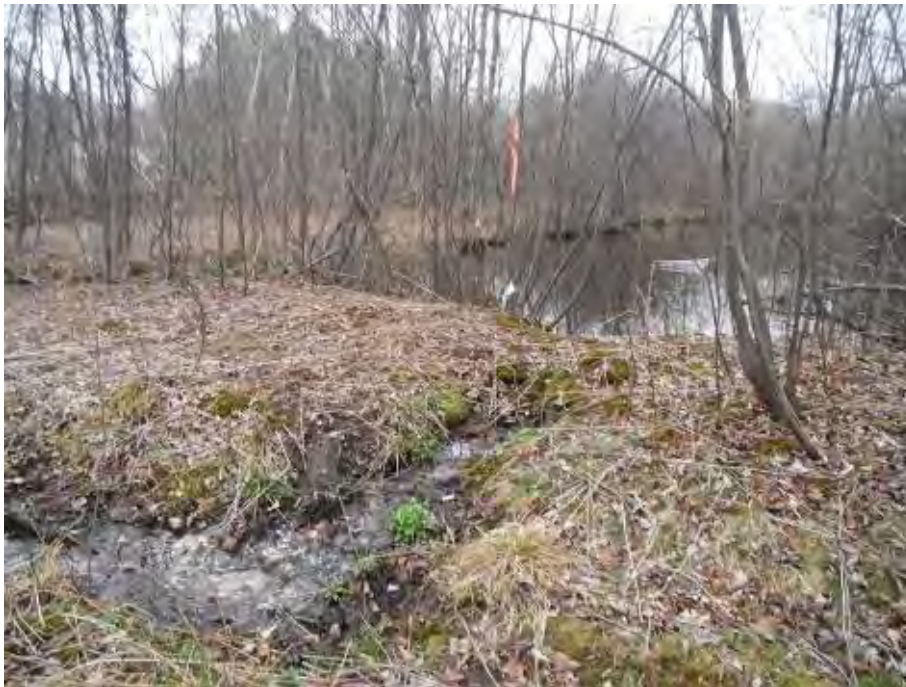
**FRAME NUMBER:** DSCF0567.JPG  
**PHOTOGRAPHY BY:** G. Hornok

**SCENE:** View of sediment sampling location at the edge of a pond in the potentially impacted wetlands west of Park Street. Photograph taken facing southeast.

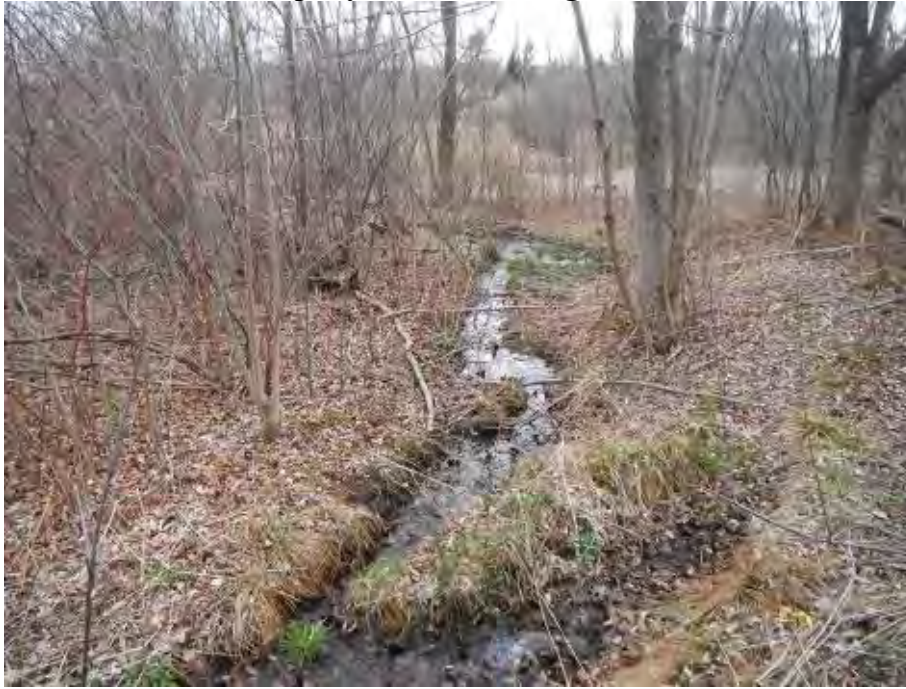
**FRAME NUMBER:** DSCF0570.JPG  
**PHOTOGRAPHY BY:** G. Hornok

**SCENE:** View of an intermittent stream located north of the ponded area within the potentially impacted wetlands west of Park Street. Photograph taken facing north.

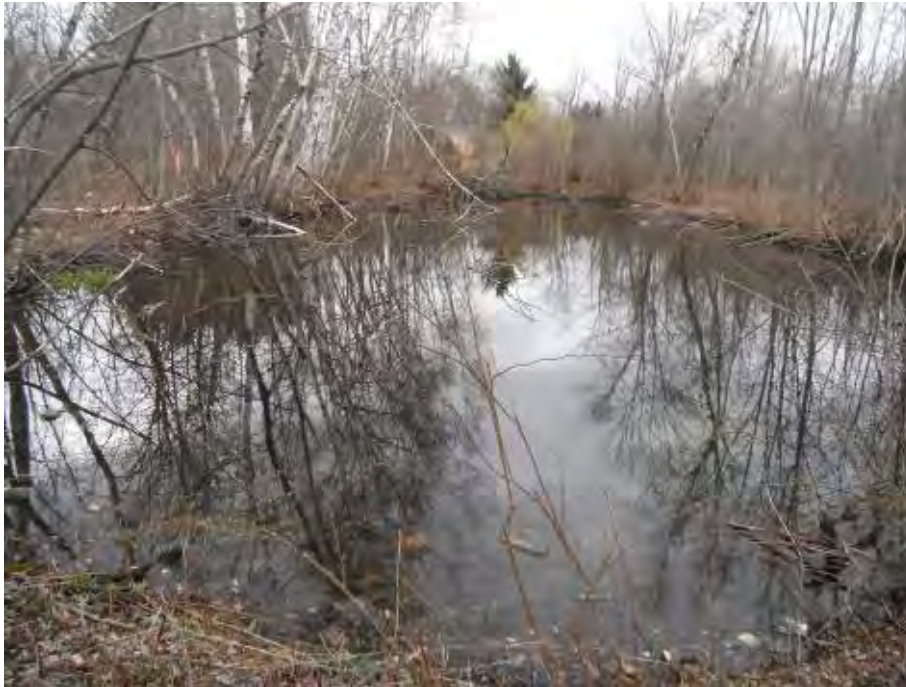
**FRAME NUMBER:** DSCF0571.JPG  
**PHOTOGRAPHY BY:** G. Hornok

**SCENE:** View of a ponded area in the potentially impacted wetlands west of Park Street. A sediment sampling location is visible to the left of the pond, indicated by orange flagging tied to a tree. Photograph taken facing southeast.

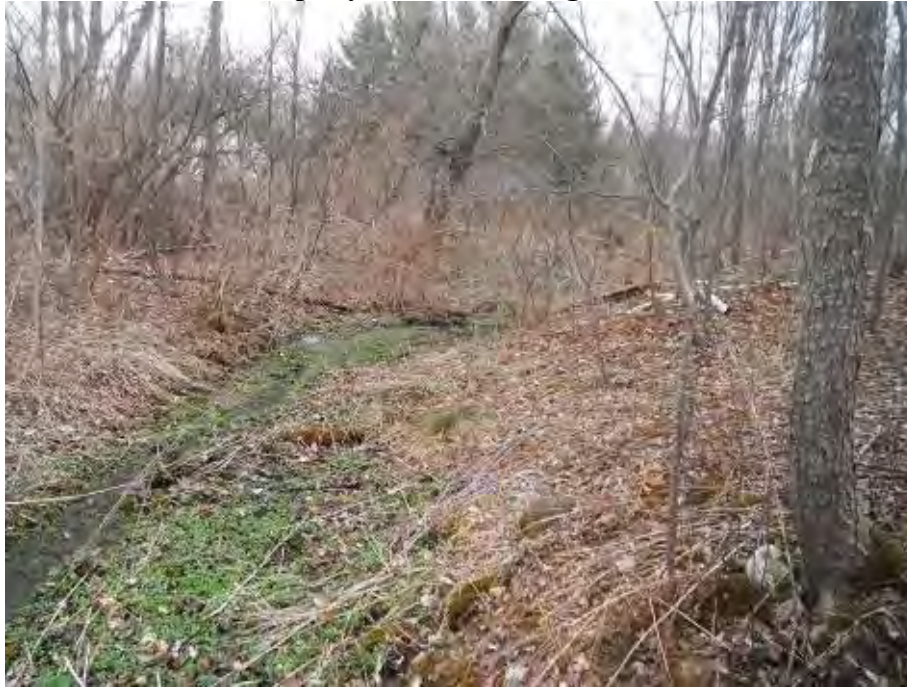
**FRAME NUMBER:** DSCF0573.JPG  
**PHOTOGRAPHY BY:** G. Hornok

**SCENE:** View of an intermittent stream in the potentially impacted wetlands west of Park Street. Residences along Park Street are visible in the background. Photograph taken facing east.

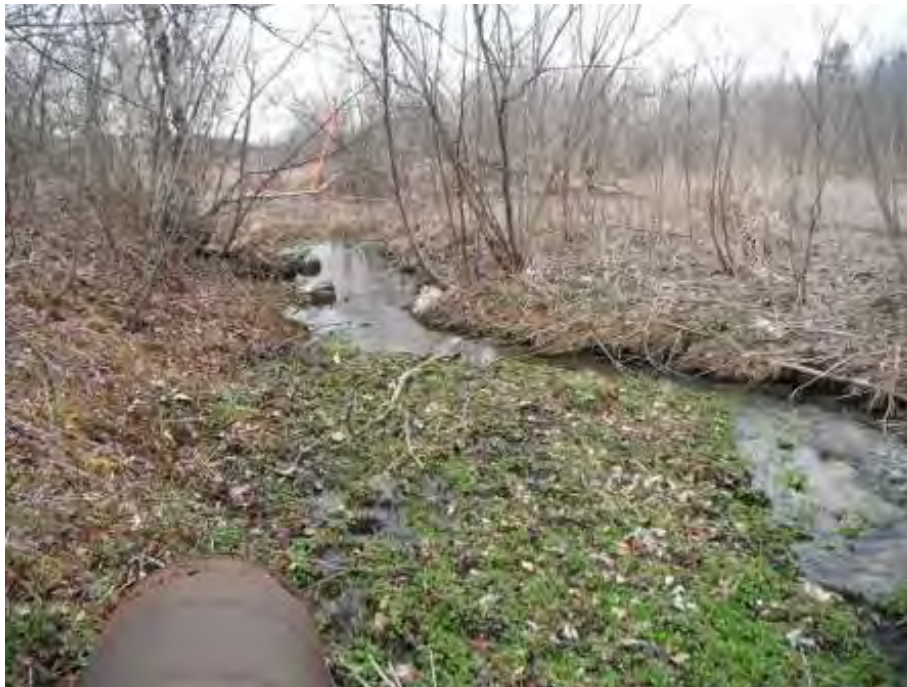
**FRAME NUMBER:** DSCF0576.JPG  
**PHOTOGRAPHY BY:** G. Hornok

**SCENE:** View of sediment sampling location, indicated by orange flagging, near an exposed drum in the potentially impacted wetlands west of Park Street. Photograph taken facing north.

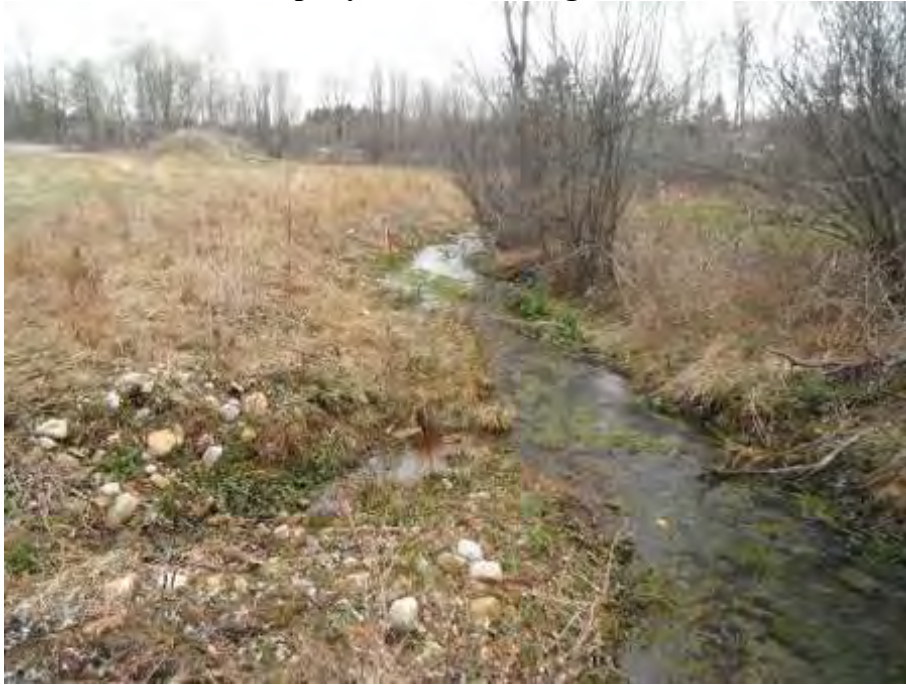
**FRAME NUMBER:** DSCF0579.JPG  
**PHOTOGRAPHY BY:** G. Hornok

**SCENE:** View of several sediment sampling locations along western edge of an unnamed stream in potentially impacted wetlands west of Park Street. The commercial plaza parking lot is visible to the left. Photograph taken facing north.

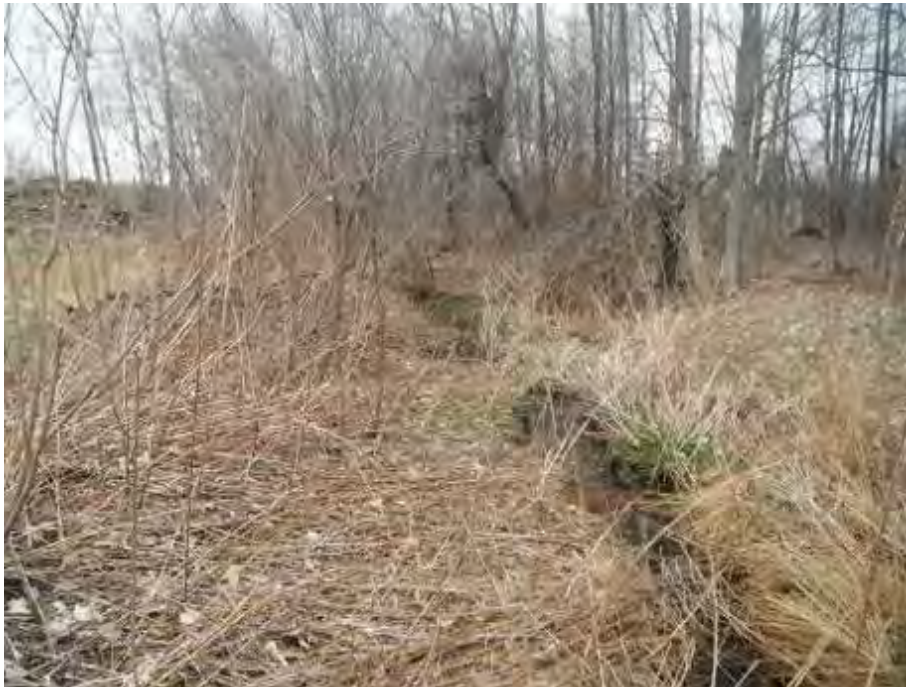
**FRAME NUMBER:** DSCF0581.JPG  
**PHOTOGRAPHY BY:** G. Hornok

**SCENE:** View of an intermittent stream in the potentially impacted wetlands west of Park Street. The pile of fill in the northwest corner of the field near the commercial plaza parking lot is visible in the upper left corner of the photograph. Photograph taken facing north.

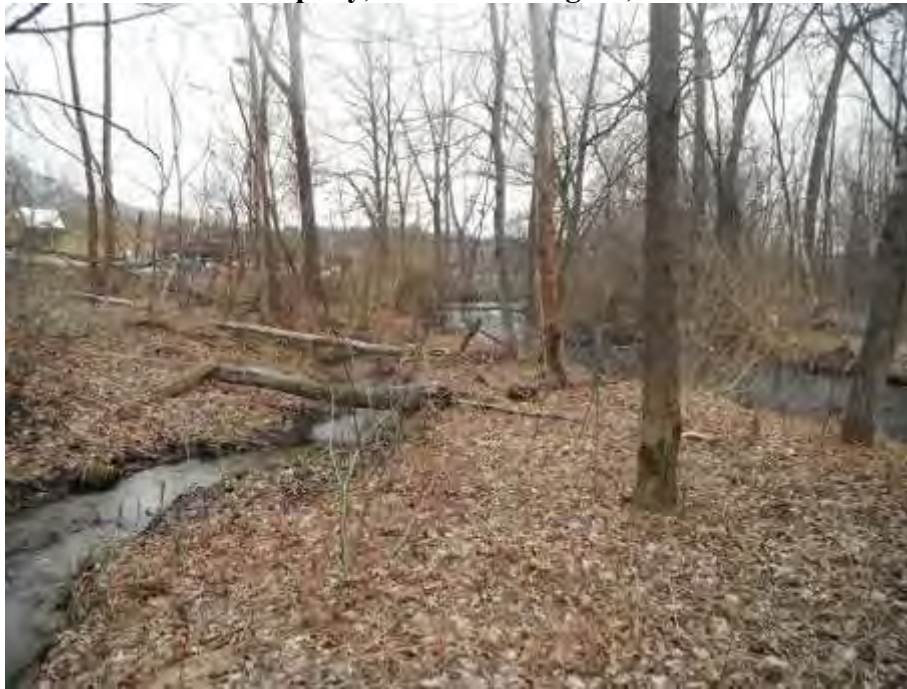
**FRAME NUMBER:** DSCF0584.JPG  
**PHOTOGRAPHY BY:** G. Hornok

**SCENE:** View of stream in wetlands where sediment samples were collected, east of the commercial parking lot and south of Kocher Drive. Unnamed converging with Furnace Brook to right and center of the photograph. Photograph taken facing west.

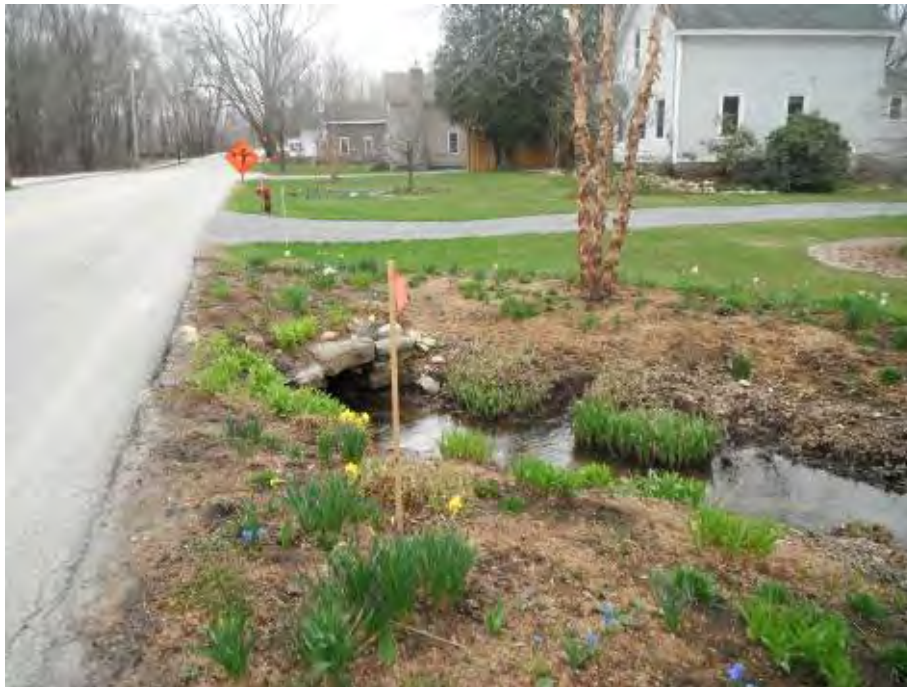
**FRAME NUMBER:** DSCF0586.JPG  
**PHOTOGRAPHY BY:** G. Hornok

**SCENE:** View of sediment sampling location on the northern edge of streambed west of Park Street on Property P005. Surface soil sample P006-SS-01 is visible on the far side of the stream on Property P006. Photograph taken facing south.

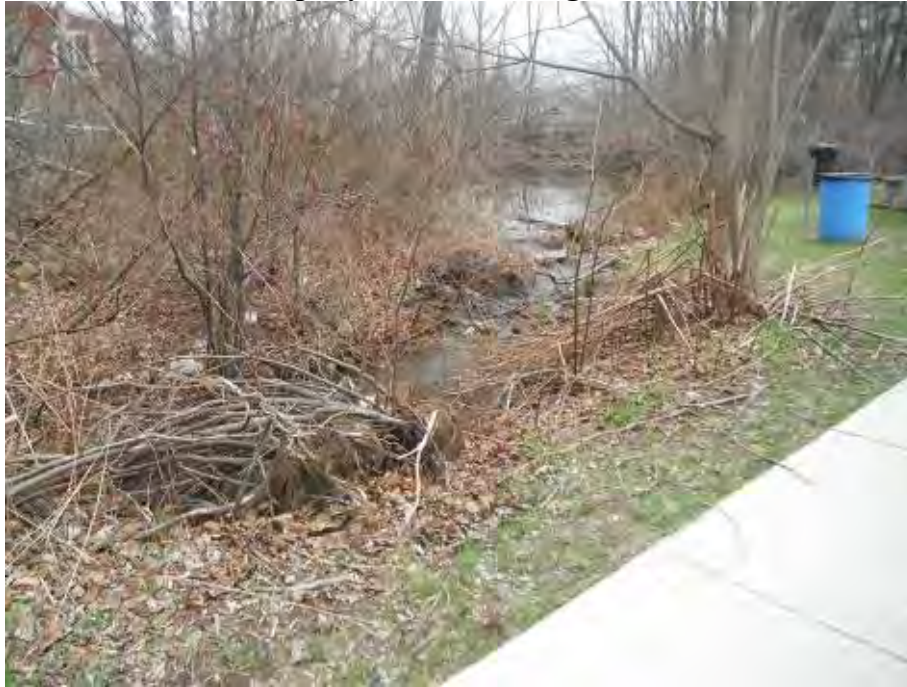
**FRAME NUMBER:** DSCF0602.JPG  
**PHOTOGRAPHY BY:** G. Hornok

**SCENE:** View of sediment sampling location, indicated by orange flagging in the left of the frame, along streambed north of Property P011 and east of Park Street. Photograph taken facing southeast.

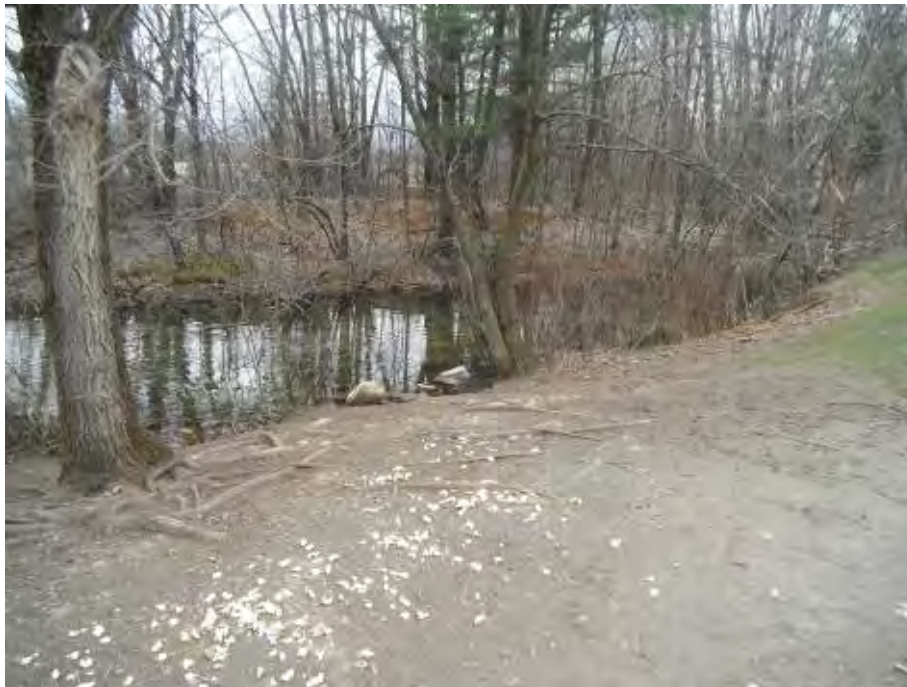
**FRAME NUMBER:** DSCF0603.JPG  
**PHOTOGRAPHY BY:** G. Hornok

**SCENE:** View of sediment sampling location adjacent to the duck pond, north of Property P011, south of Bowen Road, west of the athletic fields, and east of Park Street. Photograph taken facing south.

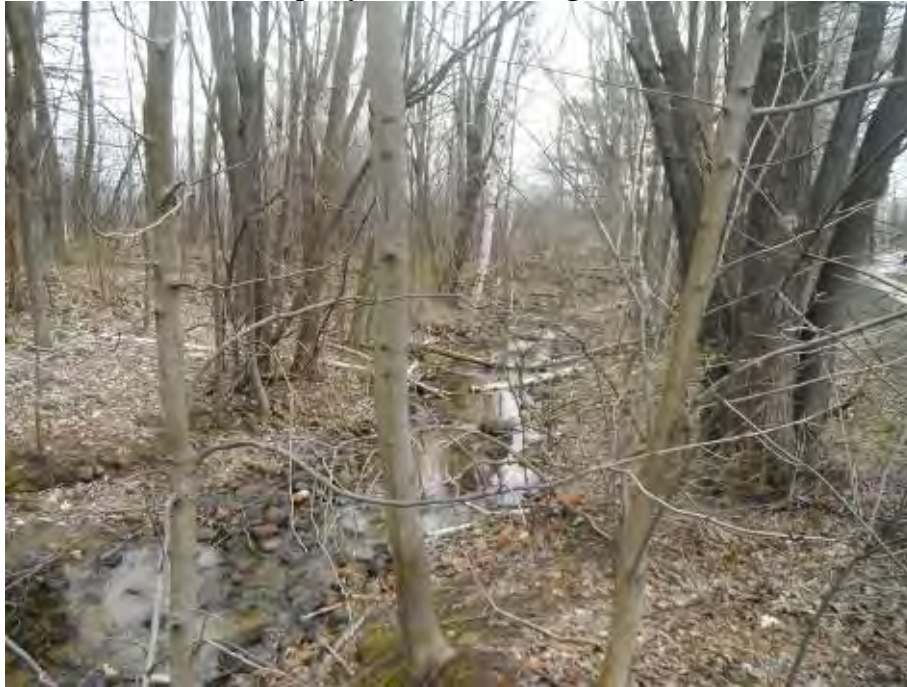
**FRAME NUMBER:** DSCF0605.JPG  
**PHOTOGRAPHY BY:** G. Hornok

**SCENE:** View of sediment sampling location along streambed north of Property P011, south of Bowen Road and the duck pond, west of the athletic fields, and east of Park Street. Photograph taken facing south.

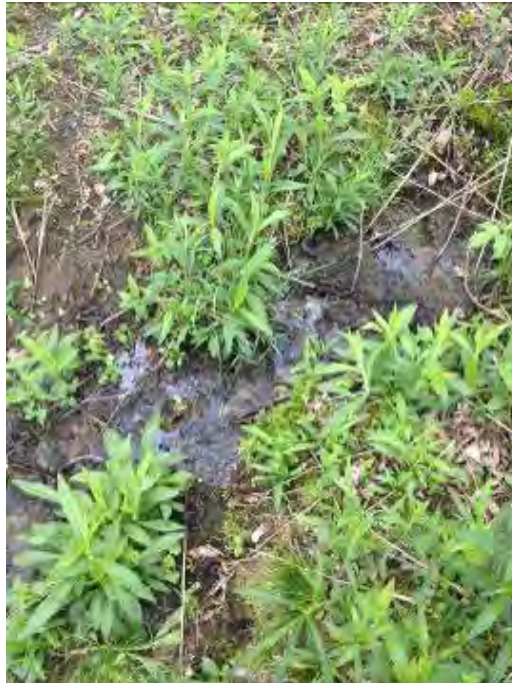
**FRAME NUMBER:** DSCF0606.JPG  
**PHOTOGRAPHY BY:** G. Hornok

**SCENE:** View of suspected groundwater spring in the potentially impacted wetlands, north of the retention ponds. Photograph taken facing south.

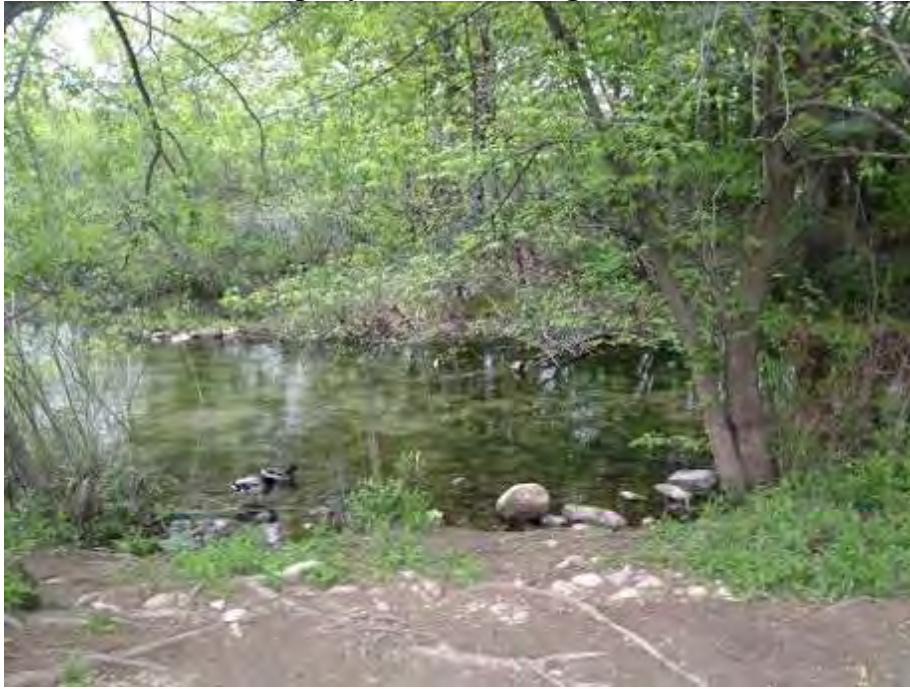
**FRAME NUMBER:** KR001.JPG  
**PHOTOGRAPHY BY:** K. Robinson

**SCENE:** View of the duck pond area east of Park Street, south of Bowen Road, west of the athletic fields, and north of Property P011. Photograph taken facing east.

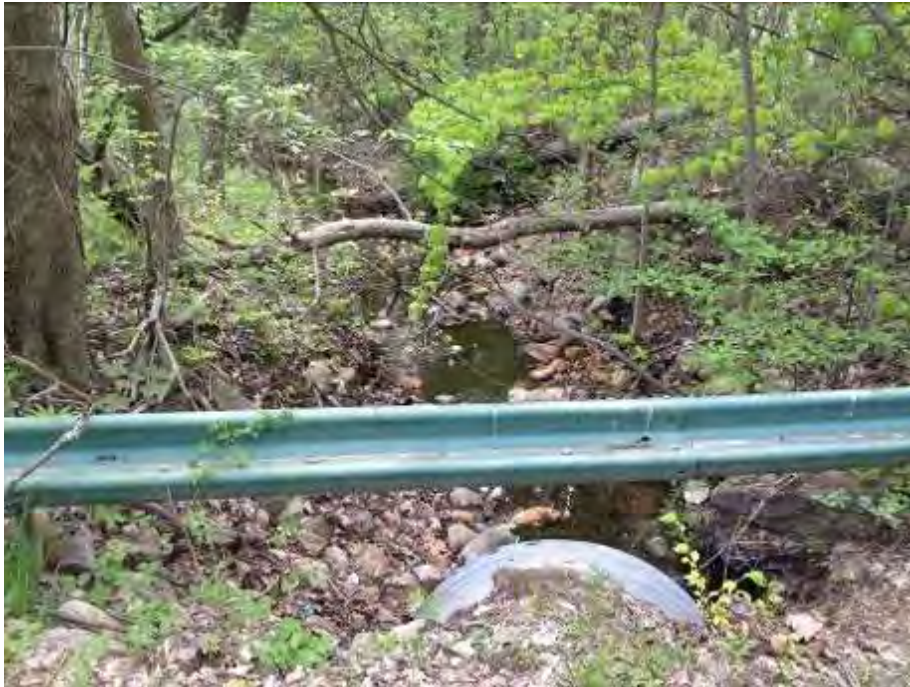
**FRAME NUMBER:** KR003.JPG  
**PHOTOGRAPHY BY:** K. Robinson

**SCENE:** View of culvert draining from the small pond located on Property P011, east of Park Street, west of the athletic fields, and south of Bowen Road. Photograph taken facing north.

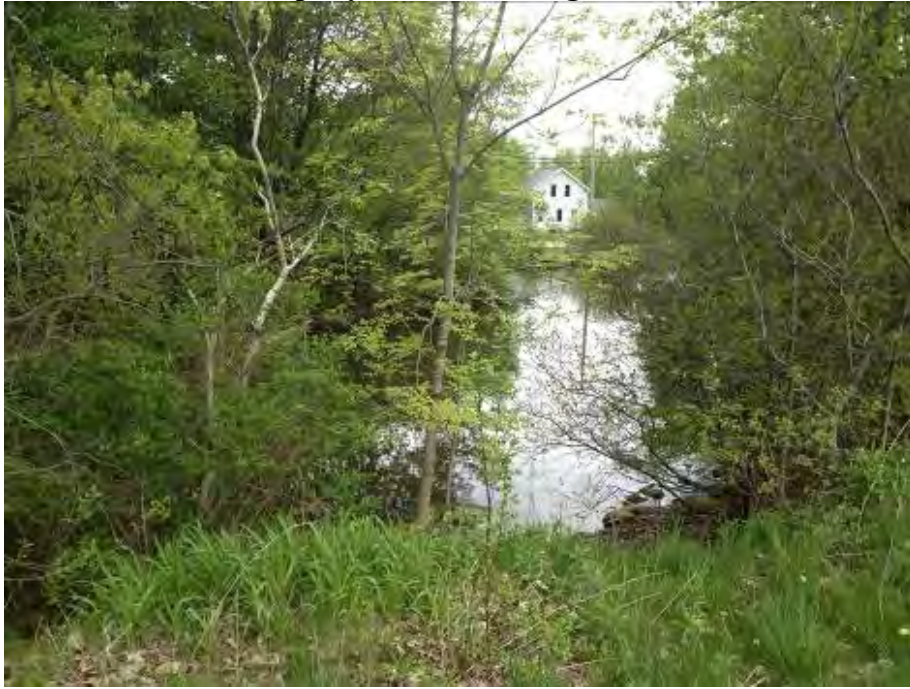
**FRAME NUMBER:** KR005.JPG  
**PHOTOGRAPHY BY:** K. Robinson

**SCENE:** View of the duck pond east of Park Street, west of the athletic fields, south of Bowen Road, and north of Property P011. Photograph taken facing northwest. Property P006 is visible in the background. Photograph taken facing west.

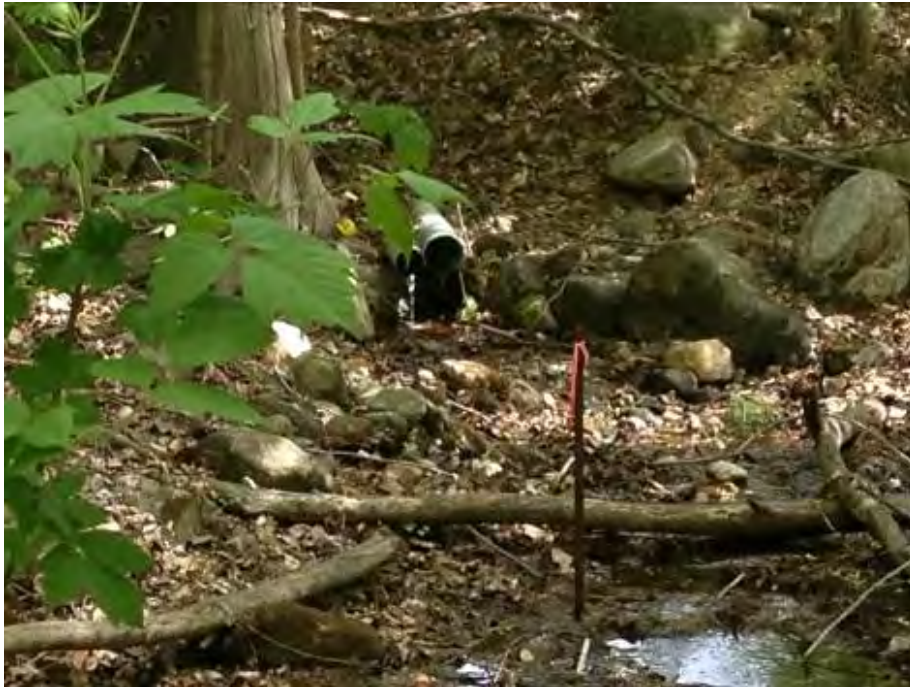
**FRAME NUMBER:** KR007.JPG  
**PHOTOGRAPHY BY:** K. Robinson

**SCENE:** View of southern-most edge of the small pond (headwaters to the unnamed stream) located on the northwestern corner of Property P011, with effluent visible in the outflow pipes. The wooden stake indicates the location of a sediment sample. Photograph taken facing south.
